Manifold Destiny: Bulldog Diving Effects Wastewater Treatment Plant Aeration Basin Manifold Air Leak for Iowa Pork Processing Plant

Rockport, Ind. – A pork processing plant’s onsite wastewater treatment facility had an air leak in the manifold that distributes air to “stones,” which oxygenate the water in its aerobic treatment basin.

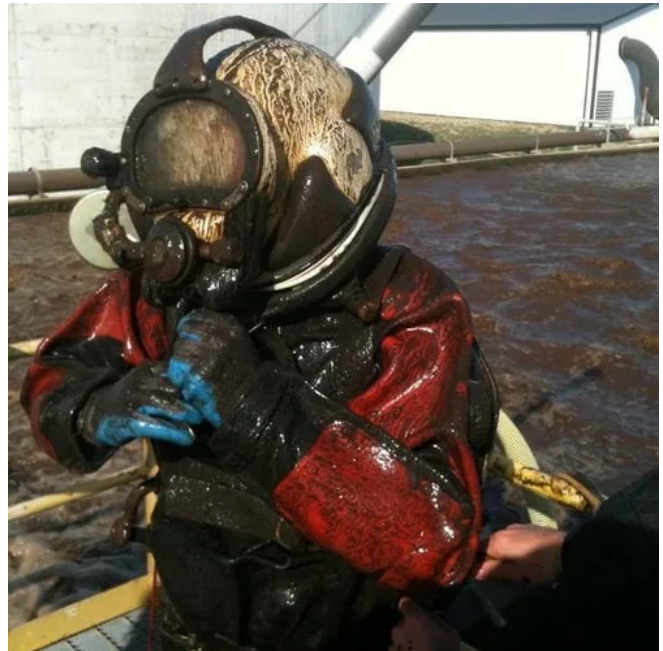
This style of treatment tank requires all repairs to be made while the plant remains in operation, without disrupting airflow. This technique avoids impacting the wastewater treatment process, which could potentially cause more problems than the original issue. However, not all repair services have the skills to navigate this situation, so Bulldog Diving LLC., with its proven team, was called in.

After inspecting the damaged area, the lead diver determined that an O-ring was blown out on an aeration stone, making it necessary for its retaining ring to be properly retightened.

The team replaced the stone's missing O-ring and retightened its retaining ring to standard specifications, sealing off the air leak and restoring 100% airflow to the rest of the aeration grid. This brought the wastewater treatment process back to normal operating status and kept the plant's treatment processes running without delay or loss of productivity. A separate repair call was avoided by the diver's inspection and diagnosis of the faulty valve, saving the client time and money.
